Inspection Report

ELWOOD MELBOURNE

Building Inspection

This report Complies with Australian Building Standards AS 4349.1-2010. Inspection of Buildings Part 1: Pre-Purchase Inspections-Residential Buildings - Appendix "C and if applicable with AS 4349.3 (VISUAL TIMBER PEST INSPECTION REPORT)

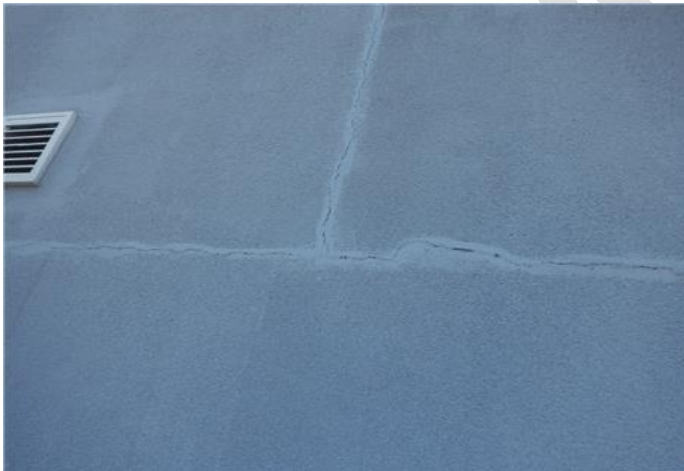
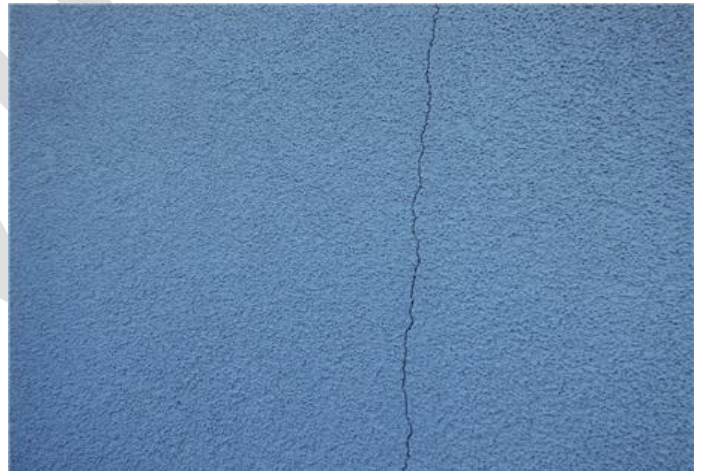
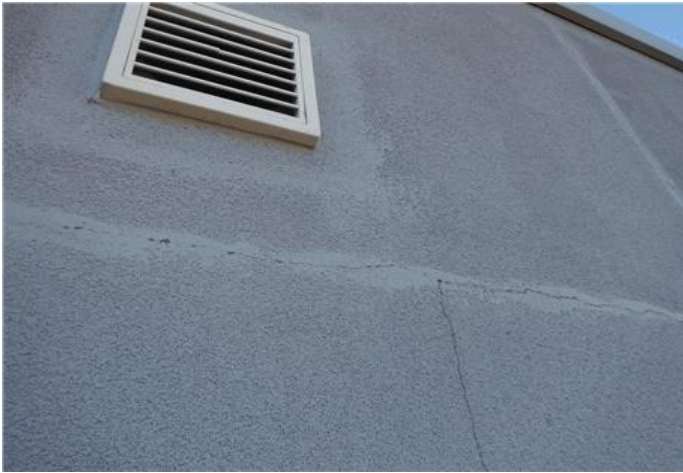
20) EXTERIOR WALL MATERIAL

Fibrous Cement Sheeting. CRACKS TO JOINS, THESE SHOULD BE SILICONE SEALED.

Cracks noted. Possible causes may be Foundation movement. Support structure deflection. Thermal movement and moisture uptake or loss, Failure under external loads. A Structural Engineer should be consulted for further evaluation and advice.

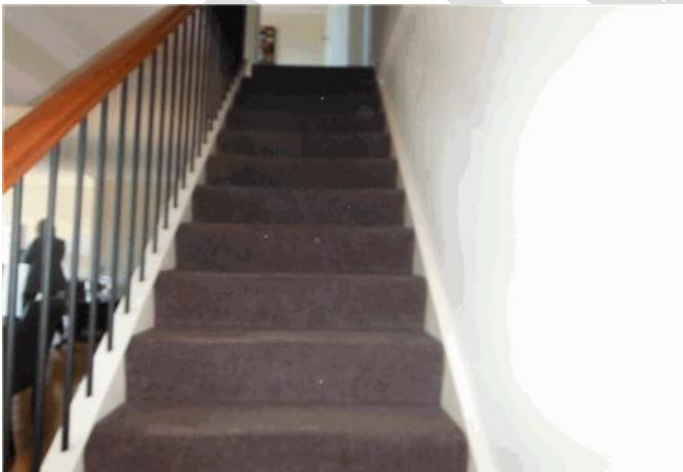
93) Condition

The stair treads squeak and require maintenance

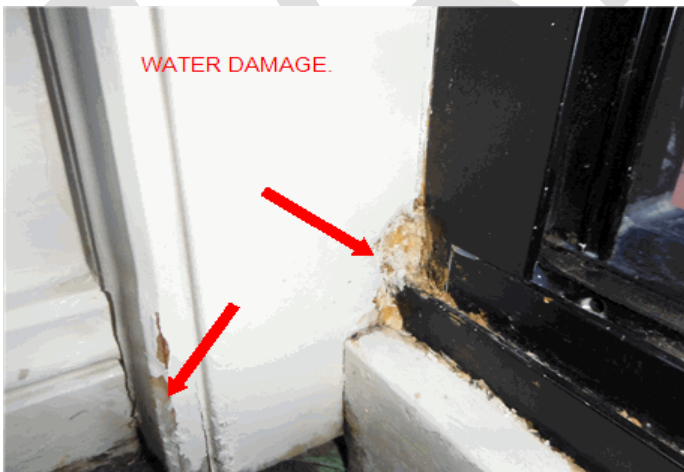
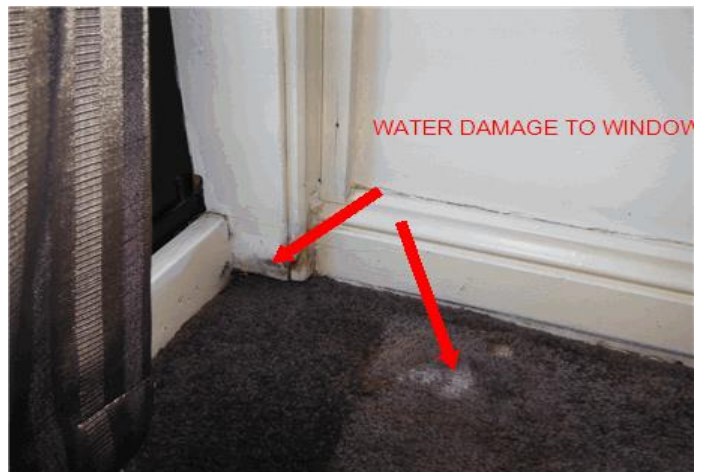
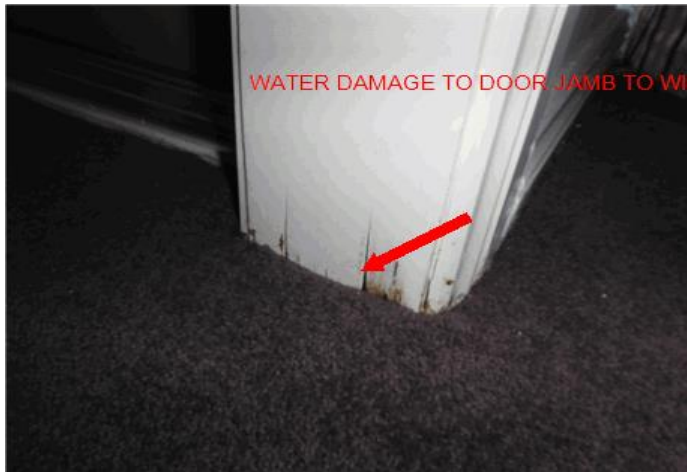
97) Walls

WATER DAMAGE TO EITHER SIDE OF WINDOW FRAME, DRY AT TIME OF INSPECTION. MONITOR WHEN RAINING.

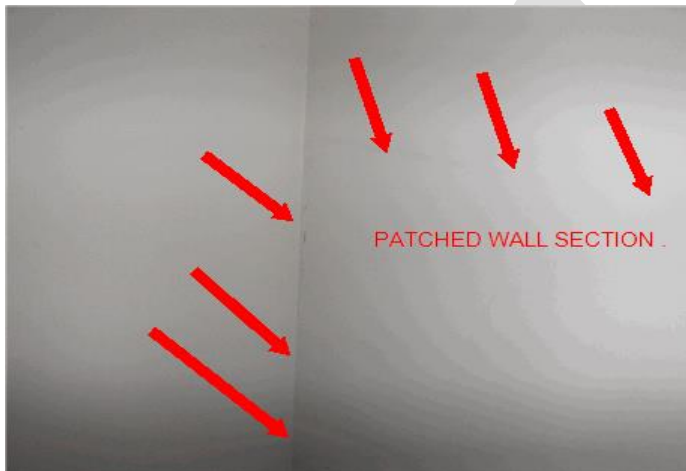
103) Walls

PATCH TO BOTTOM OF WALL THAT HAS THE SHOWER ON THE OTHER SIDE, THIS SUGGESTS A LEAK HAS BEEN REPAIRED, MONITOR.

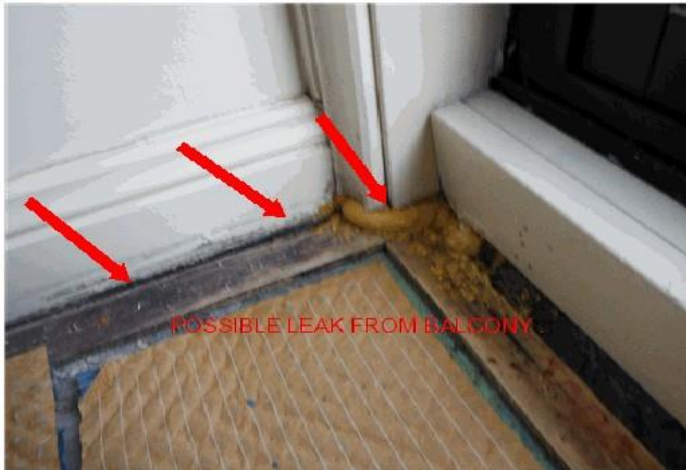
104) Windows

WATER DAMAGE TO SKIRTING AT SLIDING DOOR UNDER CARPET, DRY AT TIME OF INSPECTION. REPAIRS HAVE TAKEN PLACE, MONITOR WHEN RAINING.

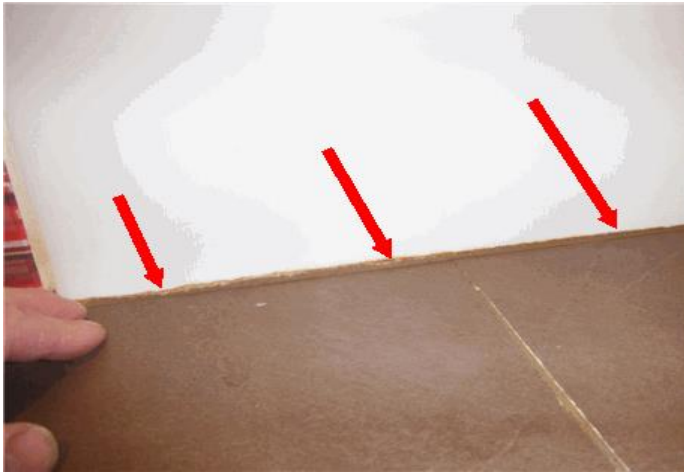
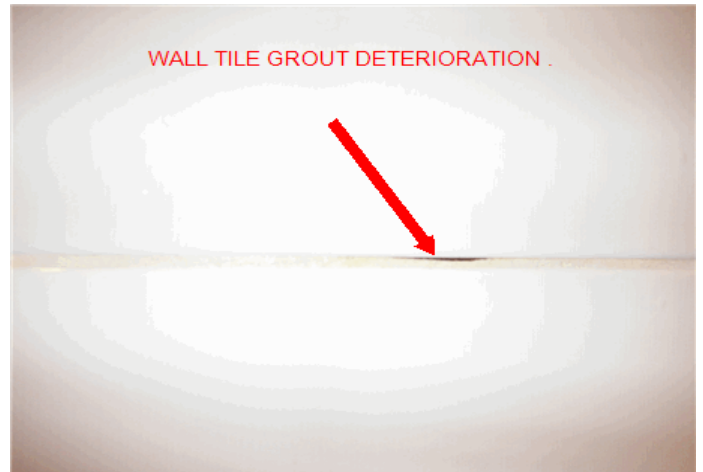
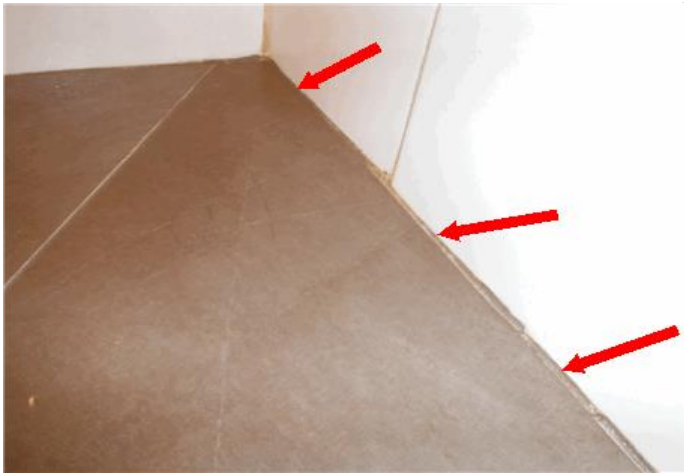
140) Shower-Walls-Screen

SILICONE SEAL SHOWER BASE AT WALL JUNCTION AND INTERNAL CORNERS.

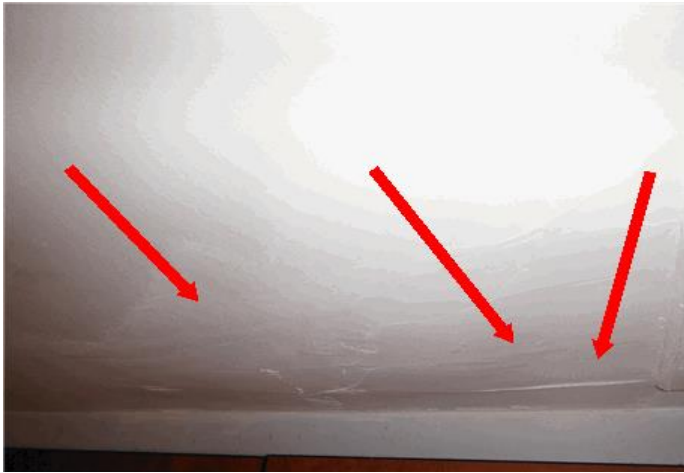
174) Ceiling

REPAIRED DAMAGE NEAR MANHOLE,ROUGHLY DONE PLASTERING.
