Inspection Report

ELWOOD MELBOURNE

Building Inspection

This report Complies with Australian Building Standards AS 4349.1-2010. Inspection of Buildings Part 1: Pre-Purchase Inspections-Residential Buildings - Appendix "C and if applicable with AS 4349.3 (VISUAL TIMBER PEST INSPECTION REPORT)

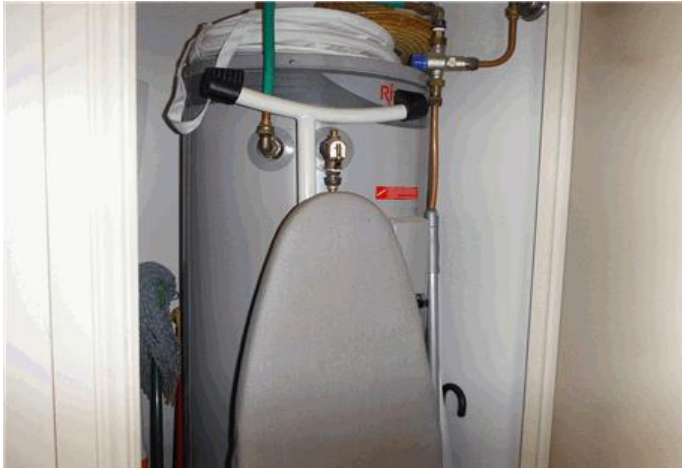
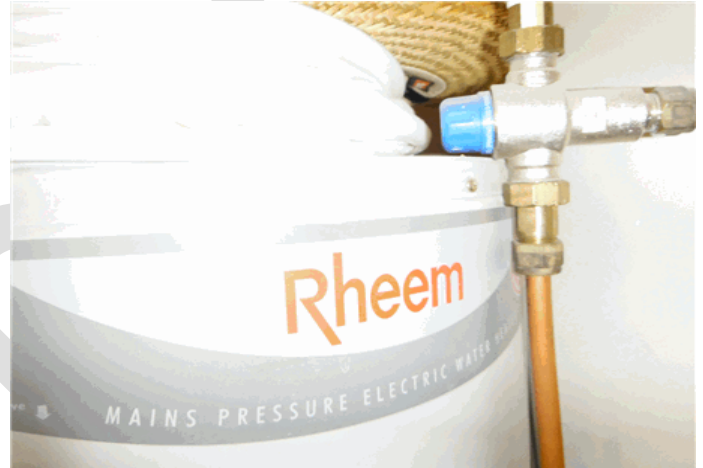
17) Hot Water Unit Findings

The hot water system appears to be in working condition. No specific tests other than running the hot water from a tap was carried out. No determination has been made as to the suitability or adequacy of the hot water system in relation to capacity or otherwise.

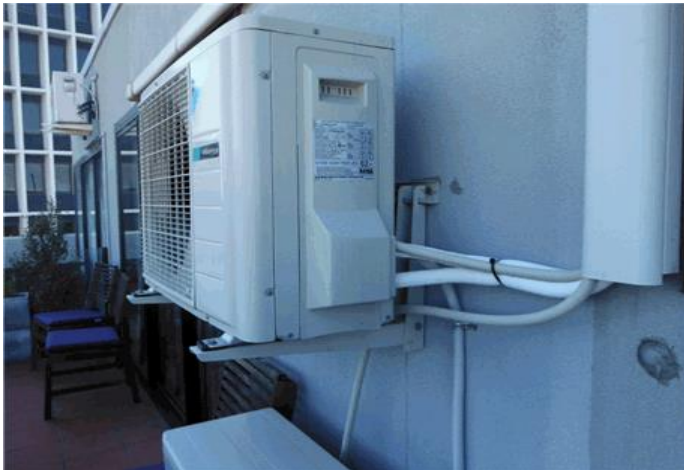
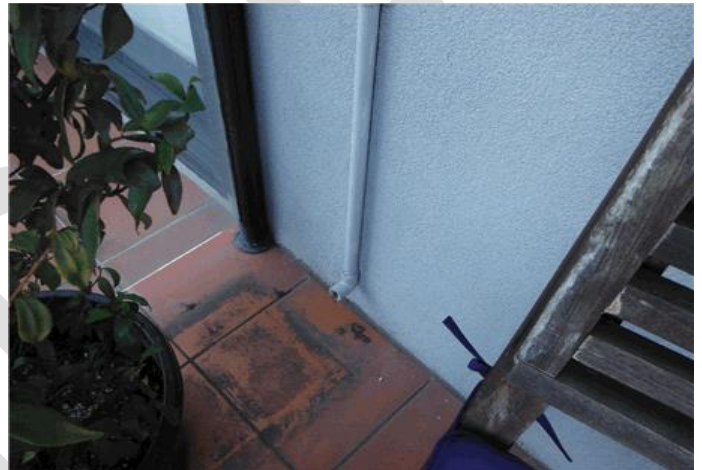
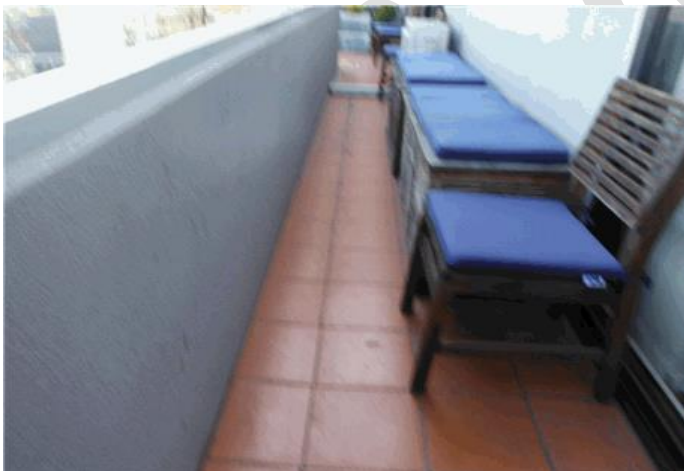
44) OVERALL CONDITION

Though We are not structural Engineers the Balcony/s appear to be in sound condition with no safety issues sighted

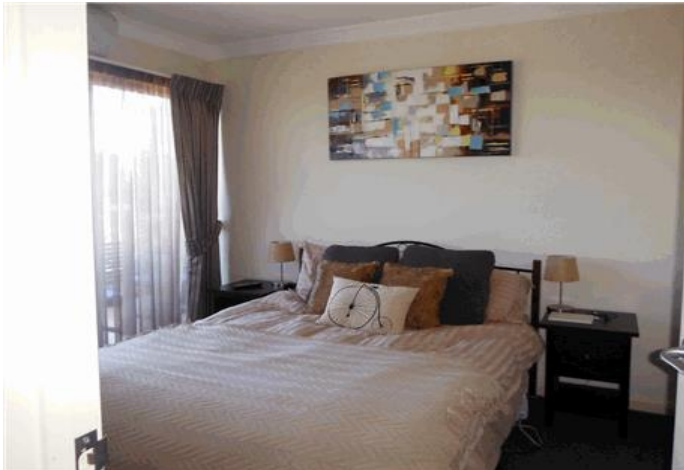
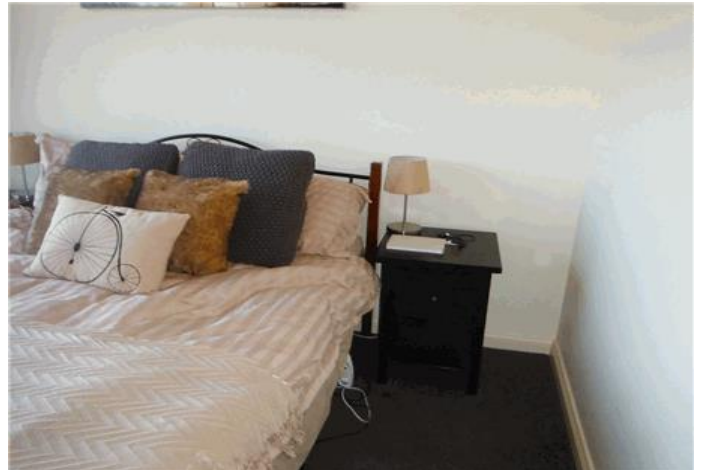
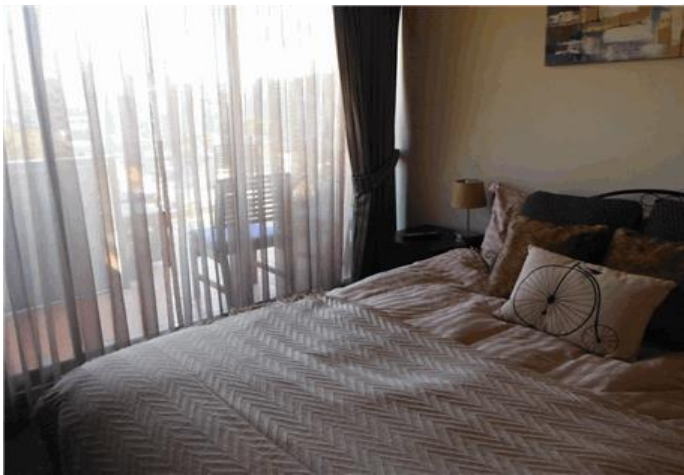
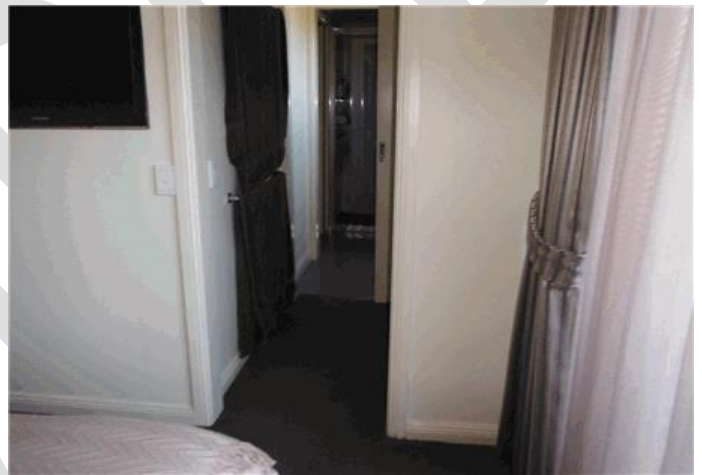
97) Walls

WATER DAMAGE TO EITHER SIDE OF WINDOW FRAME, DRY AT TIME OF INSPECTION. MONITOR WHEN RAINING.

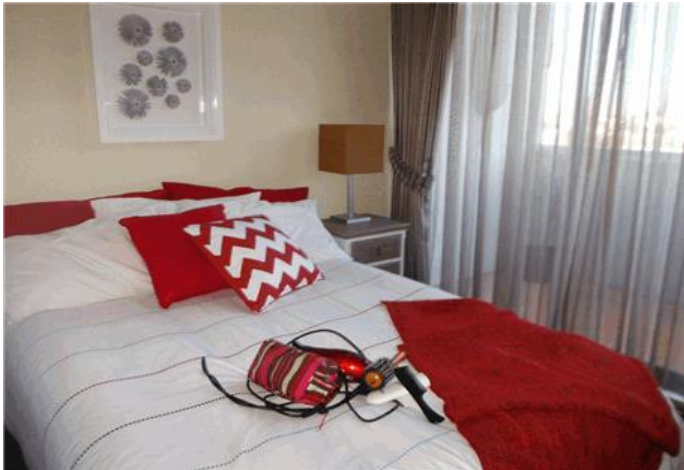
103) Walls

PATCH TO BOTTOM OF WALL THAT HAS THE SHOWER ON THE OTHER SIDE, THIS SUGGESTS A LEAK HAS BEEN REPAIRED, MONITOR.
